# REHABILITATION OF THE MONTEMOR TUNNEL

Alexandre PINTO, JetSJ Geotecnia Lda., Portugal, [apinto@jetsj.pt](mailto:apinto@jetsj.pt)

The aim of this paper is to present the main design and construction criteria adopted at the Montemor Tunnel Rehabilitation Project, in order to fulfil the minimum safety requirements, according to the Directive 2004/54/EC of the European Parliament, for tunnels in the Trans-European Road Network with more than 500m in length. The Montemor Tunnel, under operation since 1994, has two twin tubes, with an overall length of 740m each, and is located at the A9 motorway, at the Lisbon external ring road (Figure 1). Taking into account the Tunnel safety requirements, the following issues are pointed out: geological, hydro geological and structural conditions, fire resistance, including the upgrading of mechanical and electrical infrastructures.

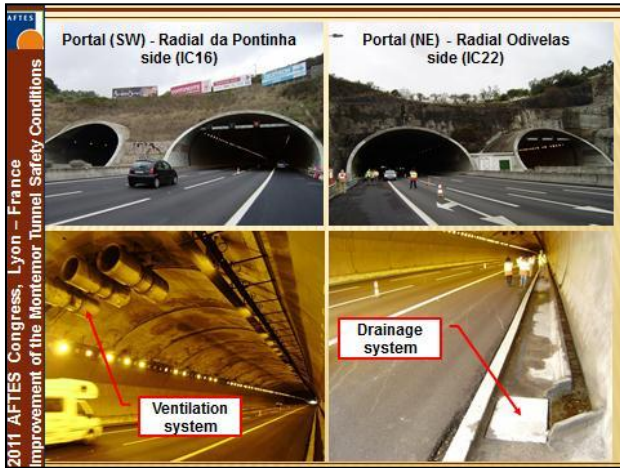
Figure 2: View of the tunnel portals, as well as of both the existent ventilation and drainage systems

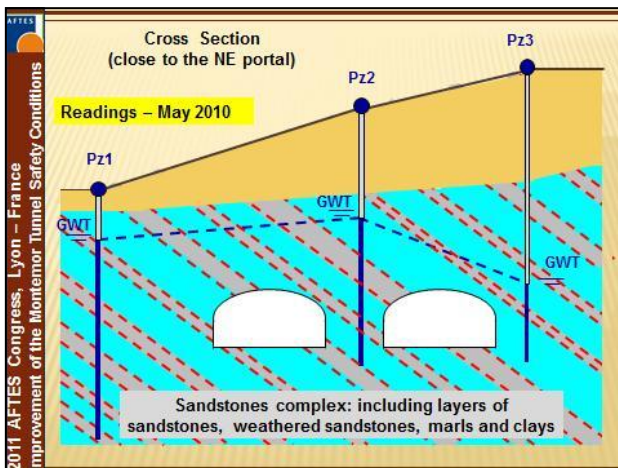
Figure 3: Hydrogeological cross section

In order to confirm all the main hydrogeological conditions, a very important input for the Montemor Tunnel Rehabilitation Project, nine piezometers were installed in three cross sections. The piezometer readings (Figure 3) allowed the confirmation of the main hydrogeological scenario. This situation led to the installation of new geodrains in order to assure the location of the ground water table below

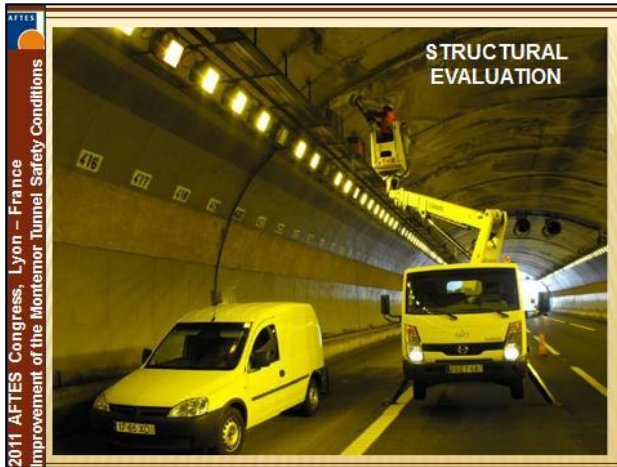
In order to confirm this information, as well as to assess the effective structural resistance, several nondestructive or slightly destructive diagnostic tests were performed (Figures 7 and 8):

Figure 7: Tunnel structural evaluation

The obtained results allowed, in general, the confirmation of the main information stated at the Tunnel original Project.

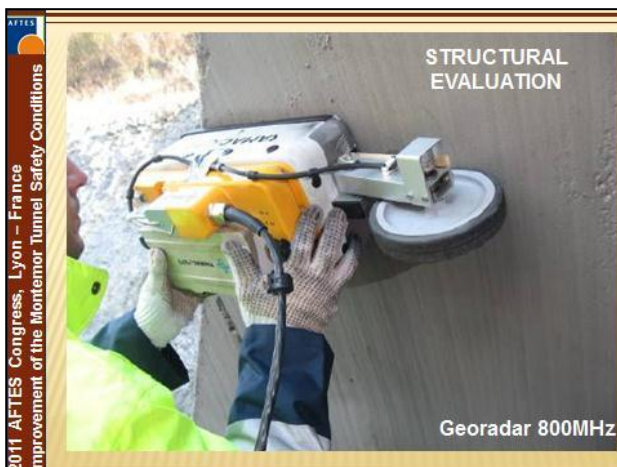
Figure 8: Structural evaluation using georadar

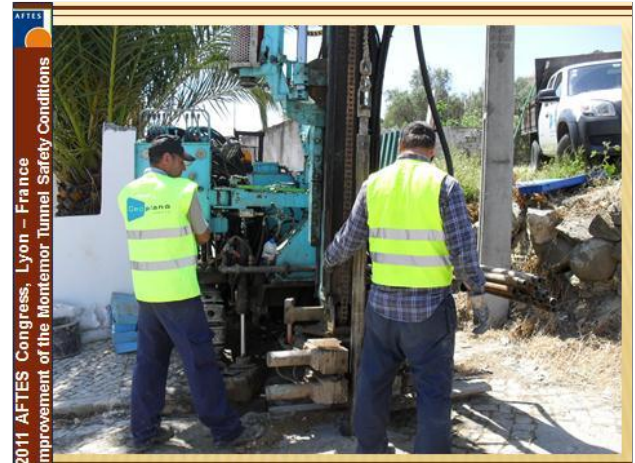
As already stated, in order to confirm all the main hydrogeological conditions, nine piezometers were installed, corresponding to the Tunnel 3 cross sections. The piezometer readings (Figures 3 and 9) allowed the confirmation of the main hydrogeological scenario, leading to the proposal for the installation of new geodrains, as well as to the implementation of a monitoring and survey plan, in order to assure the permanent location of the ground water table below the Tunnel base.

Figure 9: Piezometer installation

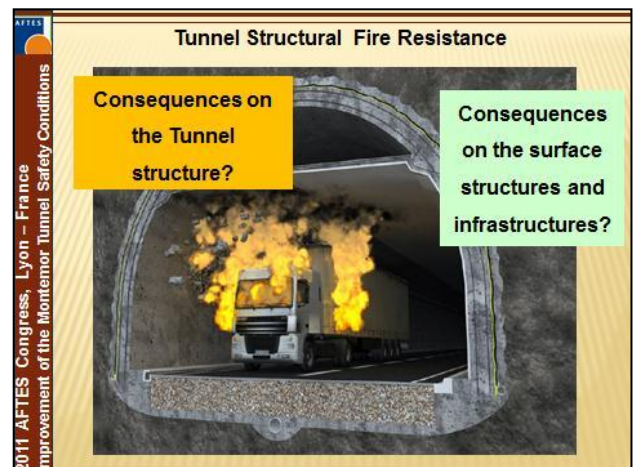
According to the European Parliament order n°2004/54/CE, it is mandatory to assess the Tunnel fire resistance (Figure 10). In particular if the eventual local collapse could, as consequence, lead also to the collapse of social important structures and infrastructures located at the surface. In this scenario, it was important to check the Montemor Tunnel structural resistance against fire. For this purpose and according to the collected information, the Tunnel standard fire resistance was previously classified with the criterion R180 (the load bearing function is maintained during 180 minutes of fire exposure, according to the EN1992-1-2).

Figure 10: Tunnel structural fire resistance

Taking into account the results of both calculations and diagnostic tests, at the cut and cover sections it was proposed the adoption of a layer of insulating material at the internal surfaces, acting as a passive thermal barrier. This fire protection layer, with a minimum thickness of 25mm, was formed by sprayed inorganic vermiculite cement, with the following advantages:

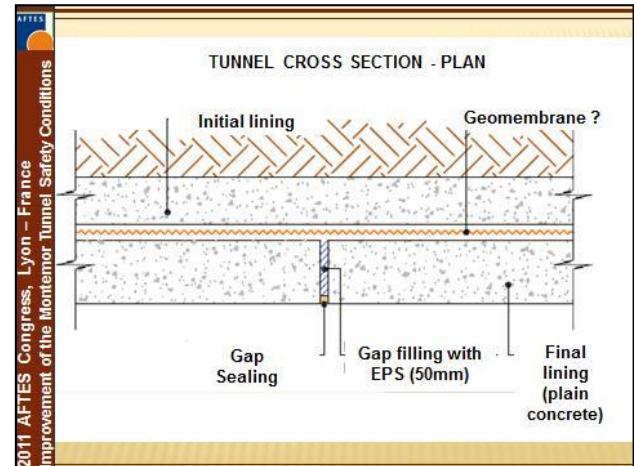
Figure 13: Detail of dilatation joint

In order to comply with the R180 classification it was also necessary to design dilatation joints, at each 25m at the concrete Tunnel final lining, with 50mm width of gap (Figure 13).
